# Apple Canyon Lake Preliminary Design Report Jo Daviess County Illinois

January 2022

Crawford, Murphy & Tilly

## PRELIMINARY DESIGN REPORT

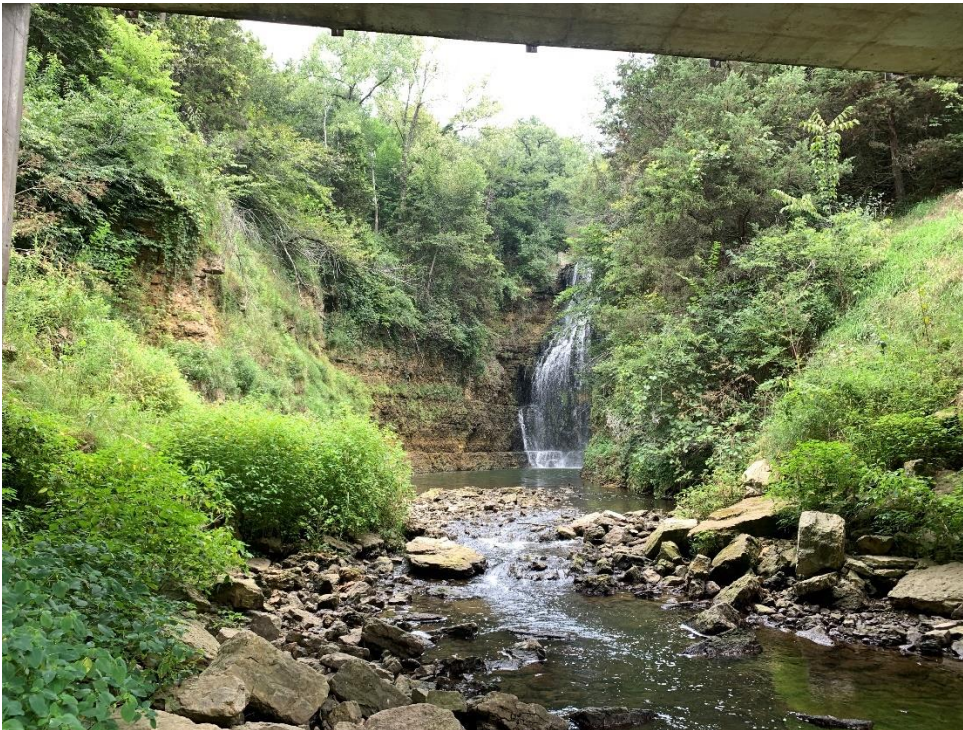
View upstream of  
bridge on South  
Apple Canyon  
Lake Road

During the site visit on August 6, 2021, a Thompson Township employee mentioned that the riprap on the upstream side of the bridge base has been replenished following a few high flow events in the past. It is recommended that larger riprap pieces be placed at the base of the bridge to prevent scour during future floods.

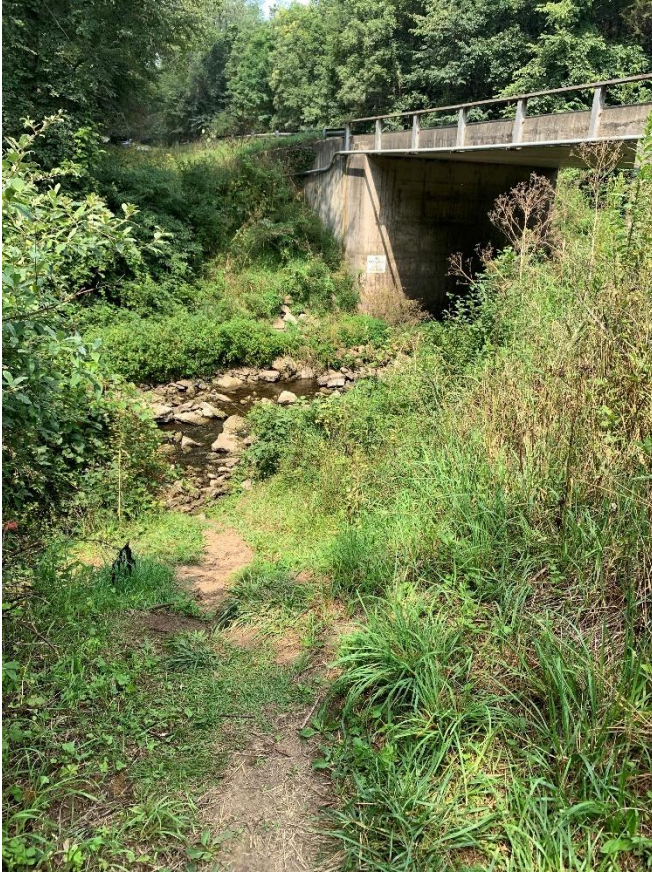
Channel downstream of bridge  
on South Apple Canyon Road

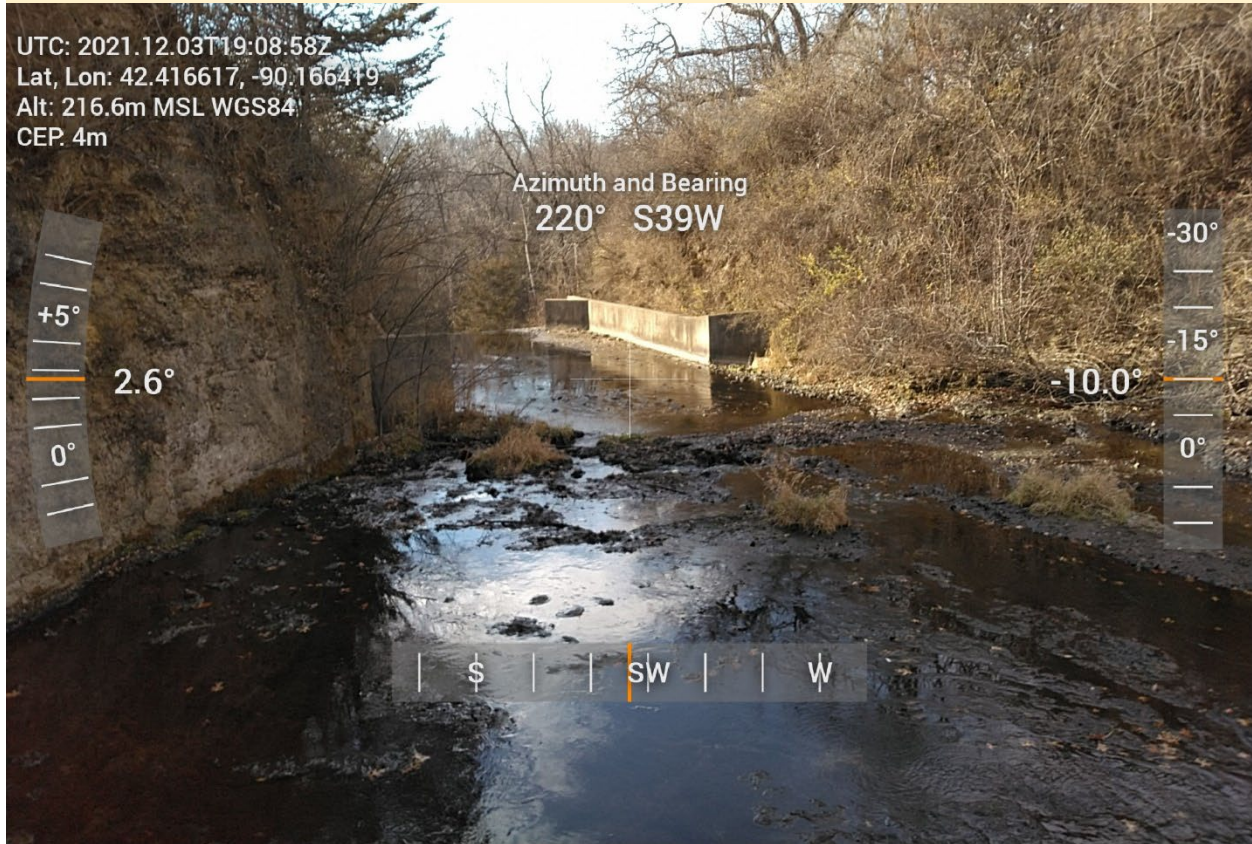
Photo: View looking NE along the SE training wall from the d/s end

- Removal or repair of existing concrete training walls appears to be needed (Distress on the southeastern training wall needs some repair (see photo above))
- Shot Crete can be applied on the exposed rock walls instead of constructing a higher concrete training wall to create a combination of formed training walls and higher anchored shotcrete walls
- Fixing cracks in the rock face down stream of the waterfall is not necessary. Noted in the on-site meeting is that there is desire by the residents to retain the drop high wall at the downstream end of the rock cut spillway.

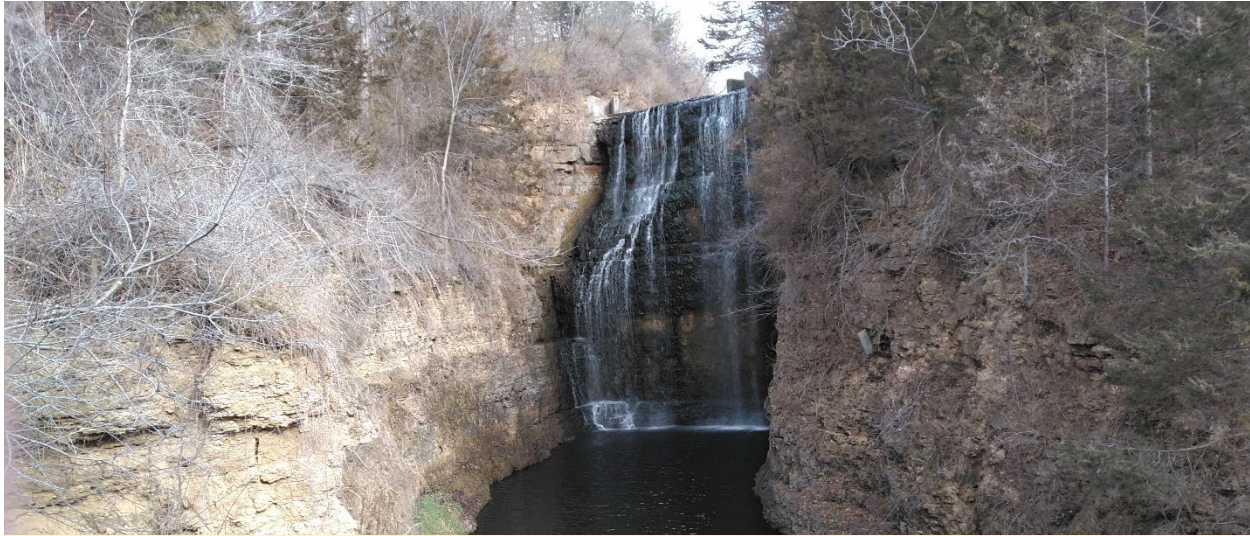
Photo: View of Plunge Pool below existing spillway discharge point

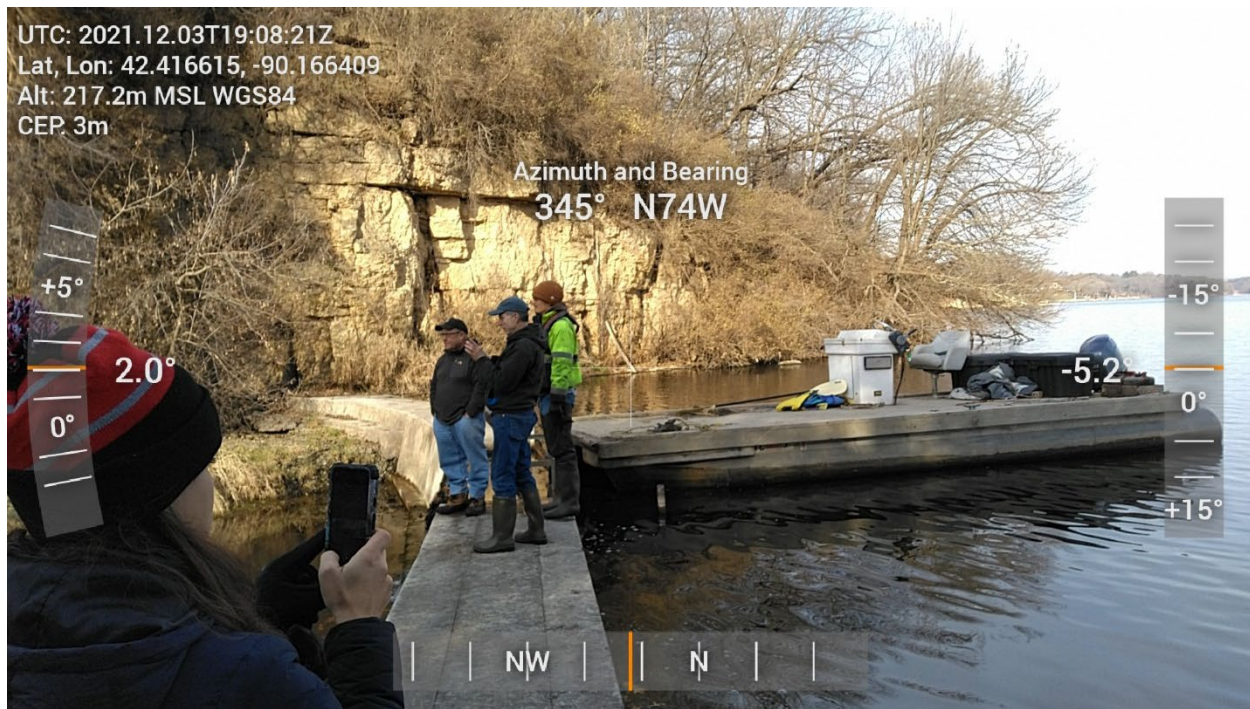
Photo: View of N-NW connection of weir wall with NW rock cut

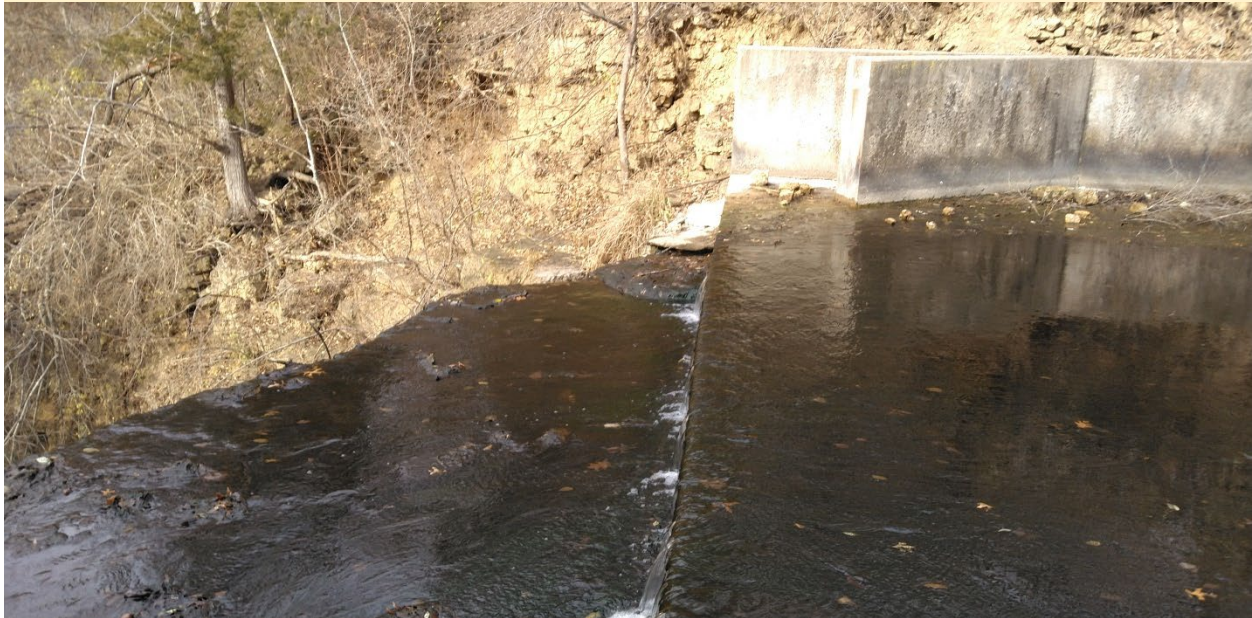
Photo: NW view of spillway discharge and overtopping erosion

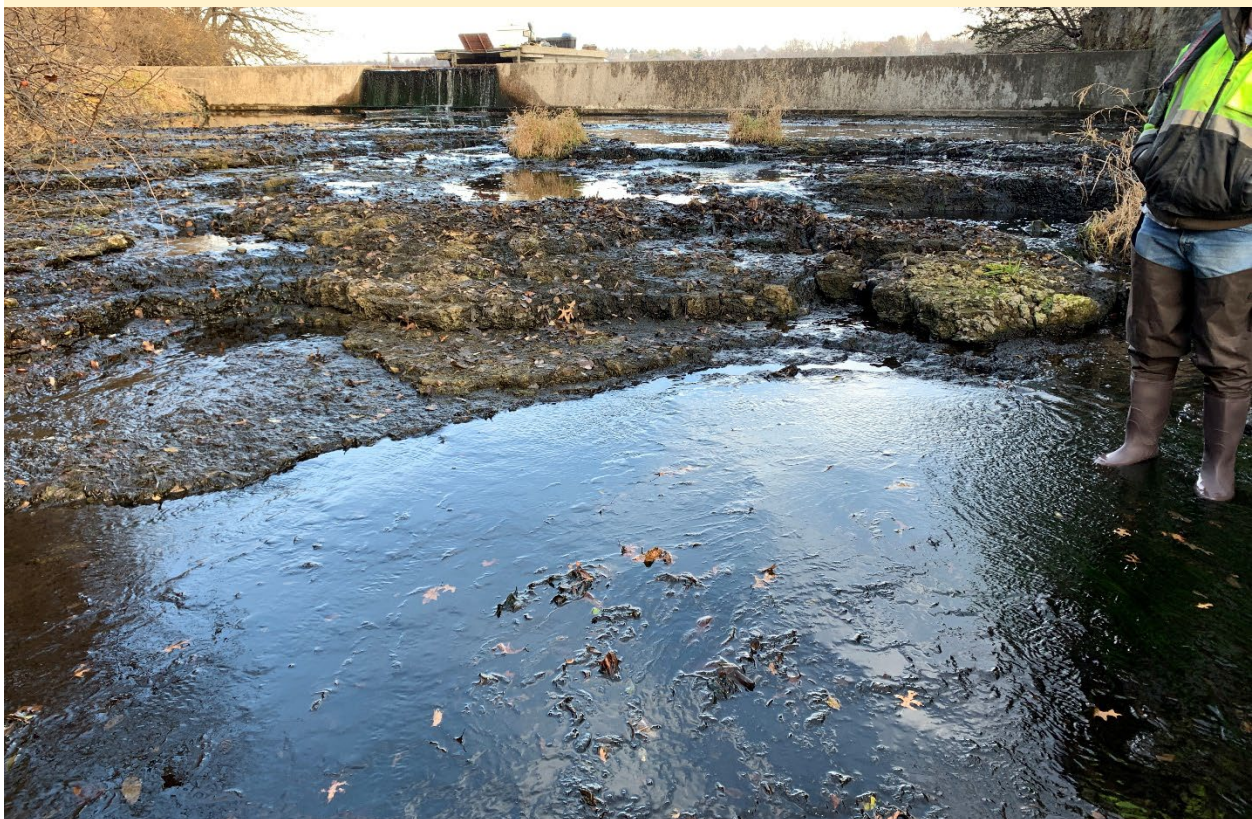
Photo: View rough rock surface of spillway channel and stop log weir
