# Apple Canyon Lake Preliminary Design Report Jo Daviess County Illinois

January 2022

Crawford, Murphy & Tilly

## PRELIMINARY DESIGN REPORT

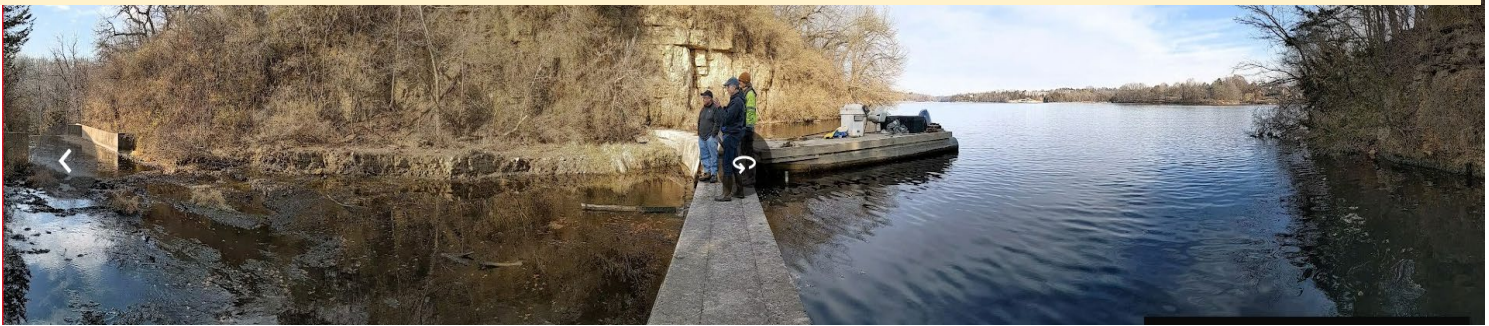
Photo: Panoramic View

**Apple Canyon Lake has reportedly experienced three unusually high flood levels since 2010 with the highest level occurring in July 2017. The peak water level was within 1 to 2 feet of the top of the Dam according to information from Apple Canyon Lake Property Owners Association (ACLPOA).**

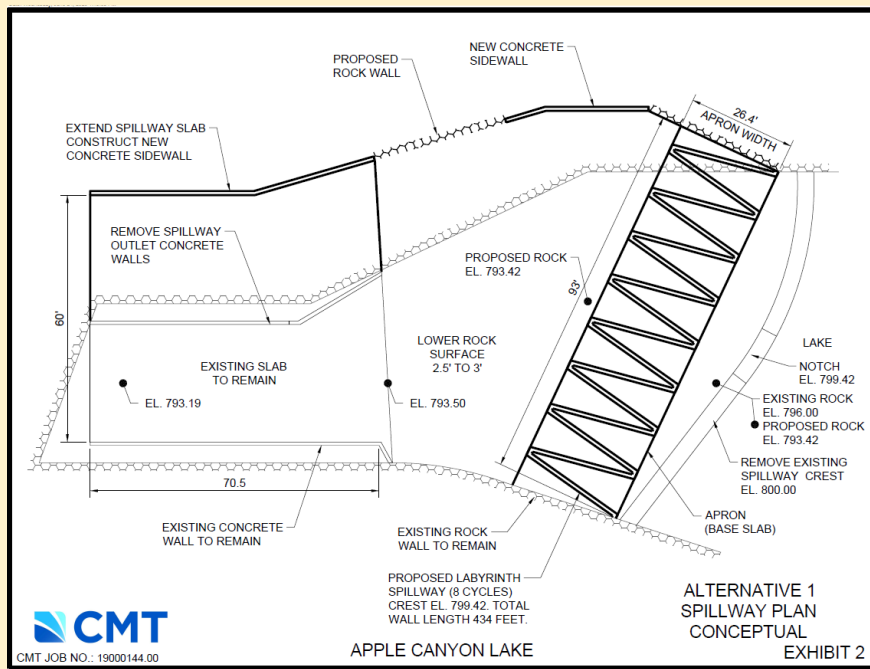
↑ Alternative 1, Proposed by CMT ↑

**Alternative No. 1** is a labyrinth spillway with a total wall length of 434 feet, overall length of 93 feet and height of 6 feet. The existing spillway channel will be widened from 28 feet to 60 feet and extending primarily into the north-western bank of the existing rock cut. The channel floor would potentially remain at the same elevation.

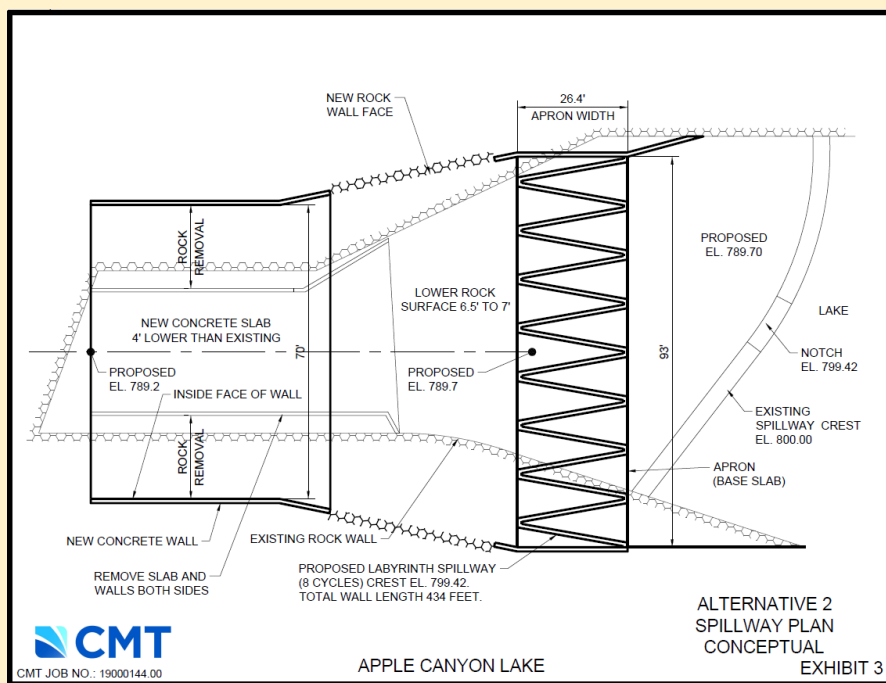
↑ Alternative 2, Proposed by CMT ↑

**Alternative No. 2** is a labyrinth spillway with a total wall length of 434 feet, overall length of 93 feet and height of 10 feet. The spillway channel will be widened from 28 feet to 70 feet on both the south-eastern and north-western sides of the existing channel and lowered by 4 feet.

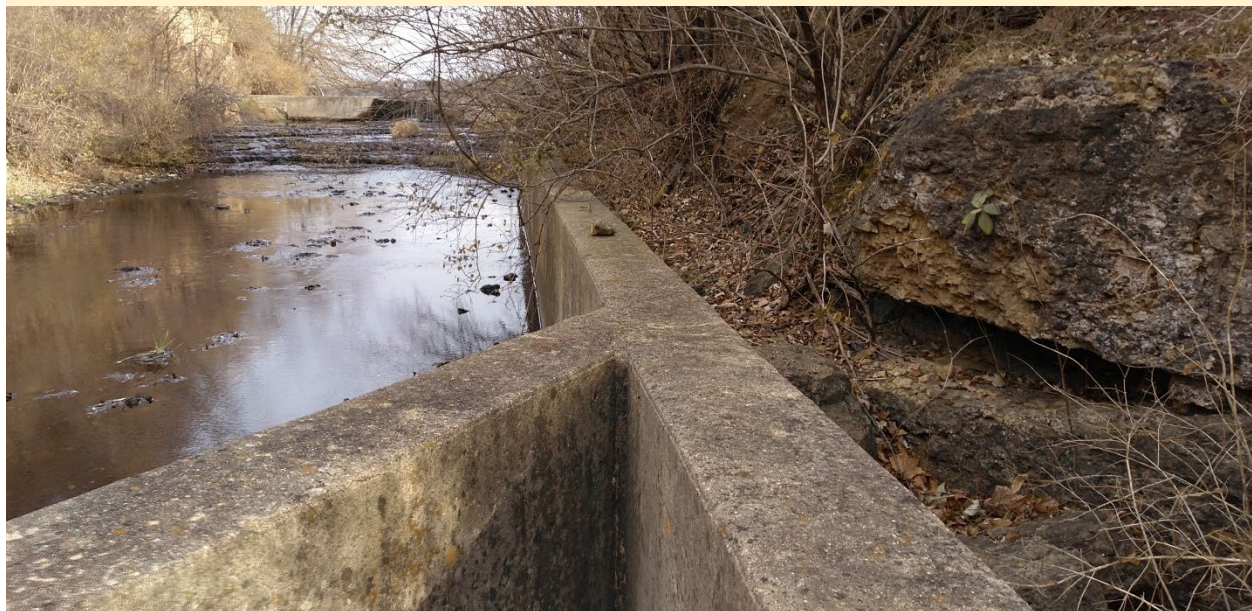
Photo: View looking NE along the SE training wall from the d/s end

- Removal or repair of existing concrete training walls appears to be needed (Distress on the southeastern training wall needs some repair (see photo above))
- Shot Crete can be applied on the exposed rock walls instead of constructing a higher concrete training wall to create a combination of formed training walls and higher anchored shotcrete walls
- Fixing cracks in the rock face down stream of the waterfall is not necessary. Noted in the on-site meeting is that there is desire by the residents to retain the drop high wall at the downstream end of the rock cut spillway.
